# AN UNKNOWN DESTRUCTIVE EARTHQUAKE IN TRANSYLVANIA IN THE 1660s – ARCHEOSEISMOLOGY OF THE INLĂCENI UNITARIAN CHURCH (HARGHITA COUNTY, ROMANIA)

*Abstract.* The 15th century Unitarian church at Inlăceni (Harghita county, Romania) was put on fire by Tartarian marauders in 1661 AD. Gothic masonry vaults collapsed, proven by archaeological excavations. A painted roof panel with Latin inscription, made in 1668, preserved these dates. An archaeoseismological analysis is provided, describing dropped keystone, tilted wall, and collapsed vault. An unknown earthquake of intensity IX occurred between the early 1660s and 1668, unrelated to the Vrancea zone, caused this destruction.

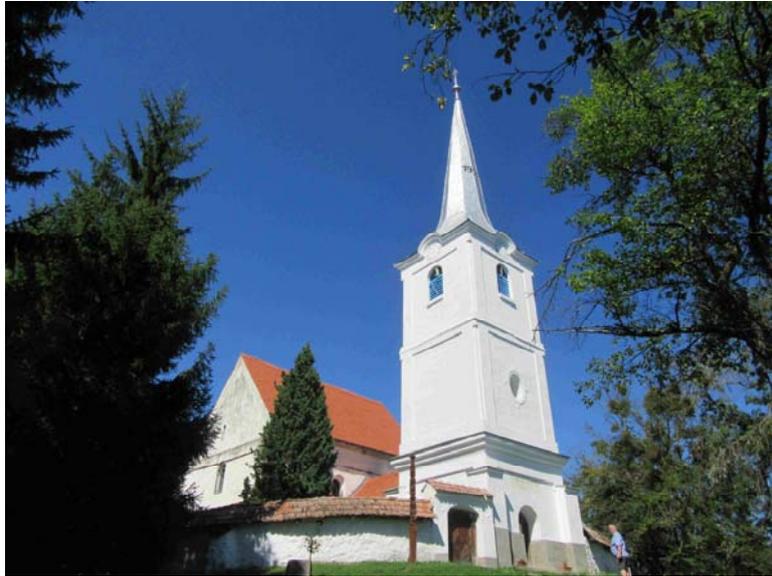
Fig. 1 – Unitarian church at Inlăceni viewed from southeast. Church was built in the 15th century, the circular wall in the 18th century, the tower in the early 19th century.

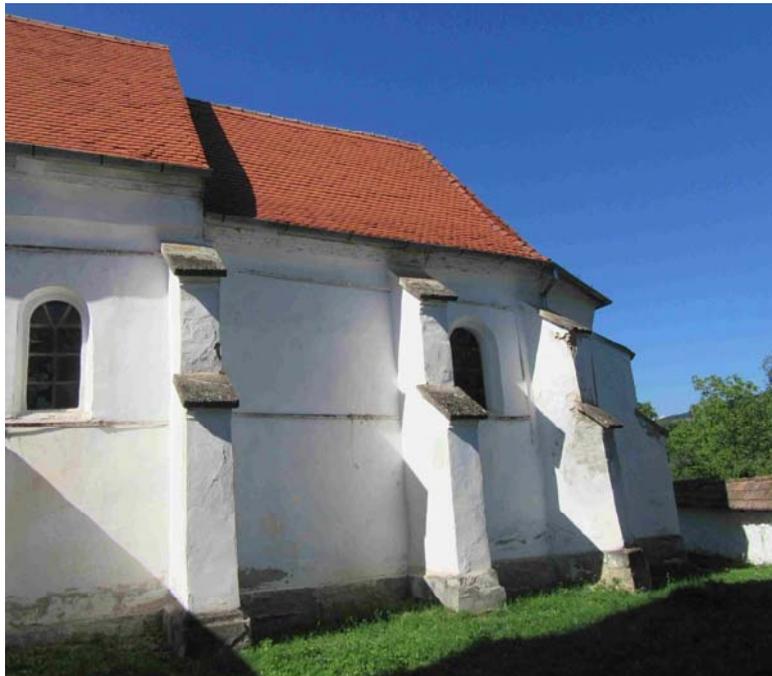
Fig. 2 – Gothic buttresses support the nave (left) and choir (right). These are the best evidence that the church had a vault. Serial numbers refer to photos in the Archaeoseismological Database [2]. #0370

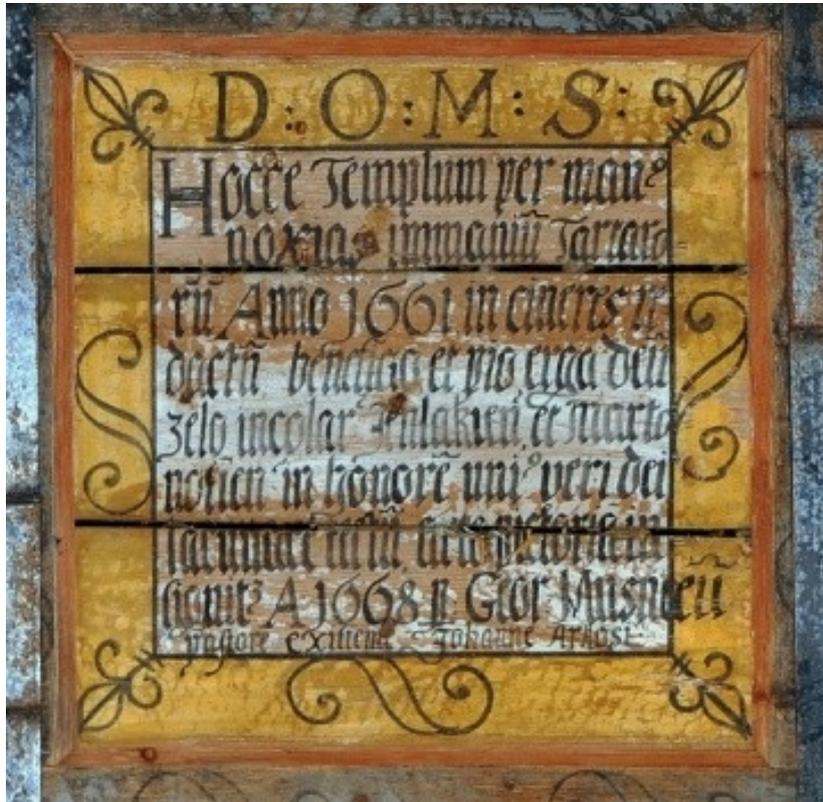
Fig. 3 – Ceiling panel with date of construction (1668). Photo: Zoltán Bagyinszki.  
<https://bagyinszki.eu/archives/10362>. Accessed 4 June 2020.

The Unitarian church at Inlăceni (Énlaka in Hungarian, Harghita county; 46° 25' 44.6" N, 25° 06' 34.5"; monument code: HR-II-m-A-12848.01 80) is famous for the painted wooden panels of the ceiling dated to 1668, and for the Hungarian runic script from the same year [1]. The vaulted gothic church was built in the 15th century. It is of moderate size, 20 by 7 m, having a nave to the west and a sanctuary to the east. A detached tower was built in the early 19th century (Fig. 1). Buttresses support both the nave and the sanctuary, indicating the presence of a former vault (Fig. 2). Collapsed vaults were substituted by a flat, wooden ceiling, decorated with painted panels. One of the panels in the nave displays the story and date of the destruction and restoration of the church (Fig. 3).

*“D. O. M. S. Hocce templum per man, noxius inmanium Tartarorum Anno 1661, in cineres reductum, beneficio et pio erga Deum zelo incolar, Jenlakens, et Martonosien, in honorem uni, veri Dei lacunare tectum arte pictoria insignit A. 1668, Georgius Muznai, pastore existente Johanne Árkosi.”* [1]. In English: “For the Only, Best and Most Powerful God. This church, incinerated in the hands of cruel Tartars in 1661, and covered by paneled ceiling through benevolence of Inlăceni and Firtănuș inhabitants and their dedication to pious devotion towards God, in honour of the only God, was decorated by the craft of painting by Muzsnai György in 1668, when Árkosi János was priest” (Fig. 3).

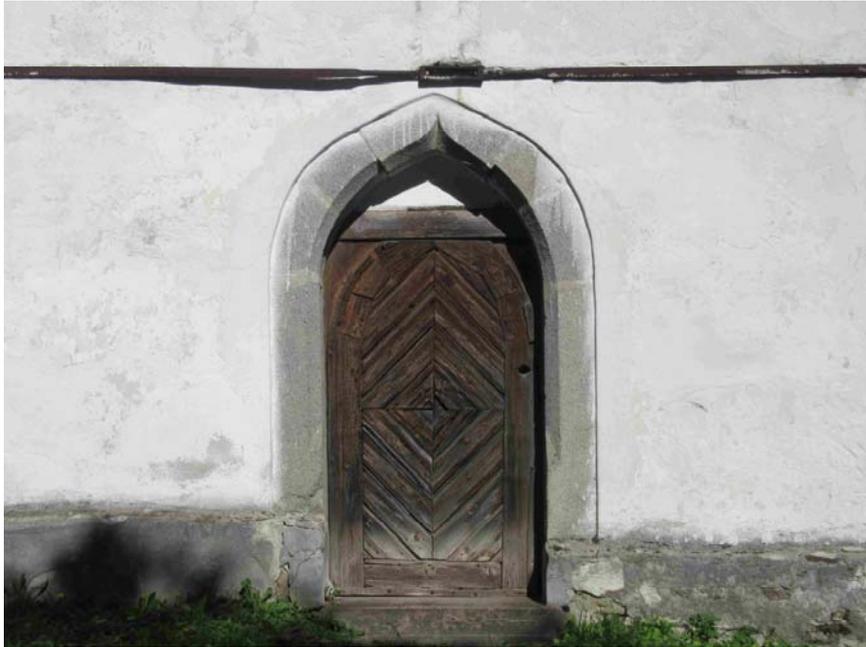
Fig. 4 – Pointed arch of the western gate. Keystone shifted downwards. #7546

This is the disused Gothic gate on the western façade (Fig. 4). There the pointed keystone has been displaced 2–3 cm downwards and 1 cm outwards, towards the viewer (Fig. 5). This symmetrical, seemingly minor displacement bears an important meaning: the church was hit by a destructive earthquake some time during its history.

Masonry blocks arranged in an arch form a very solid structure, even without using mortar – if lateral loading is countered by something, *e.g.* a buttress, well known in gothic architecture. Wall of the western façade have the same role. If these walls vibrate in plane, the distance between doorjambes oscillates. Upon extension the keystone drops by an increment, upon compression keystone remains stuck. Downshifted keystone is the best evidence for earthquake shaking [6]. Ultimately, repeated shaking allows the keystone to drop and fall freely and the arch collapses. Computer modelling [7] revealed that keystone drop occurs when there is no more significant vertical load above the arch. One can conclude that it was an earthquake which displaced the keystone of the western gate, both downwards and sideways.

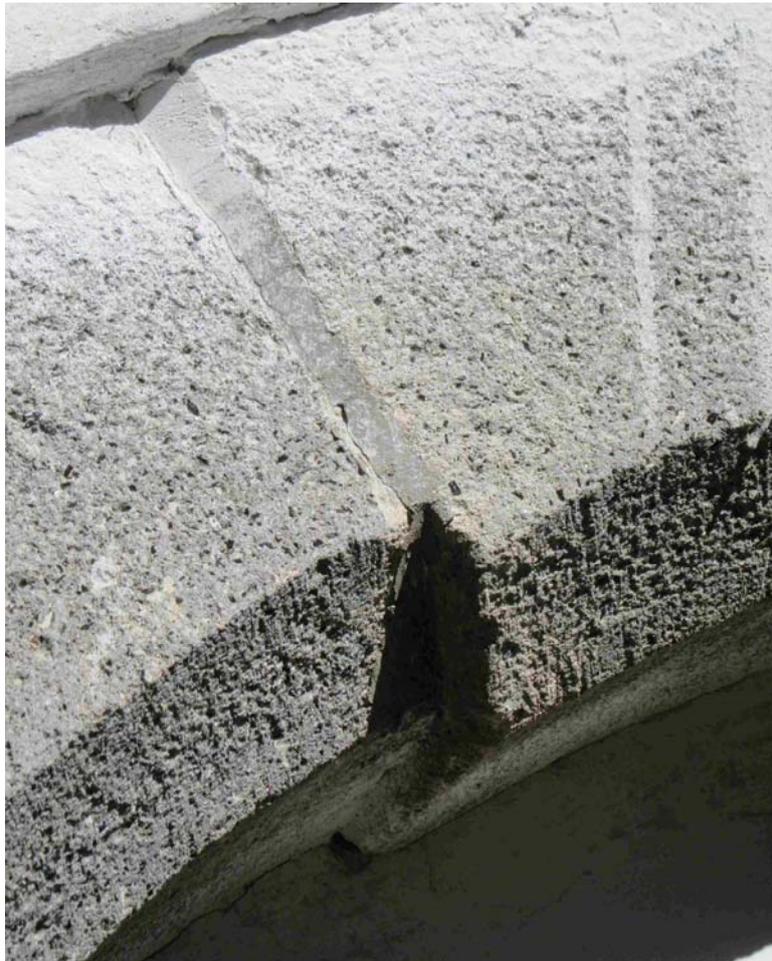
Fig. 5 – Damaged Gothic arch of the western gate. Keystone shifted downwards 2–3 cm, outwards 1 cm towards the viewer. This shift is one of the evidences of an earthquake. #7549

wooden roof and the benches within the nave [1]. Part of the nave vault collapsed: debris was found below the floor. However, the sanctuary vault survived until 1827 [8]. Despite any damage to the vaults, no fire could cause deformation either to the western wall, or to the gate within. Displacement of the keystone, both vertically and horizontally, was certainly caused by an earthquake.

Archaeoseismology uses the EAE13 intensity scale (Earthquake Archeological Effects) [14]. Dropped keystone of a masonry arch indicates I = VII or higher. Out-of-plane shift of masonry blocks suggests minimum IX intensity. The same applies for the collapsed vault and the tilted northern vault: I = IX or higher.
